Smoke and Dye Testing Summary

High Level Sewershed

Test ID	Test Type	Date Inspected	Company / Super.	Blower MH	Ground Condition	Notification Made?	Total Length
S1028-033	Smoke	8/18/2008	ADS/TM	S13WW_002MH	Dry	Yes	1,773.40

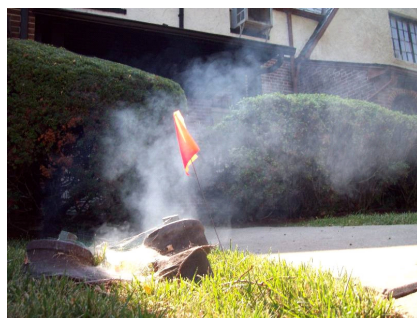
Picture \S1028-033-OB01-P01.jpg

Comments Smoke from cleanout in front yard. 3421 Wabash Ave.

Comments Front of house, 3421 Wabash Ave.

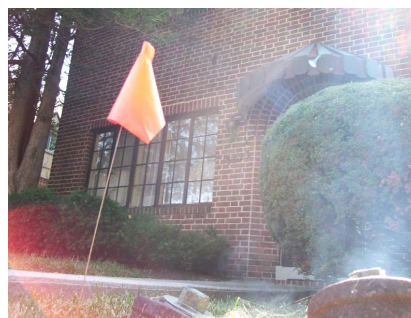
Picture \S1028-033-OB02-P01.jpg

Comments Smoke from cleanout in front yard. 3423 Wabash Ave.

Comments Front of house, 3423 Wabash Ave.

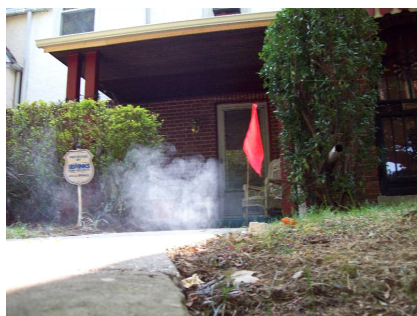
Picture \S1028-033-OB03-P01.jpg

Comments Smoke from cleanout in front yard. 3515 Wabash Ave.

Comments Front of house, 3515 Wabash Ave.

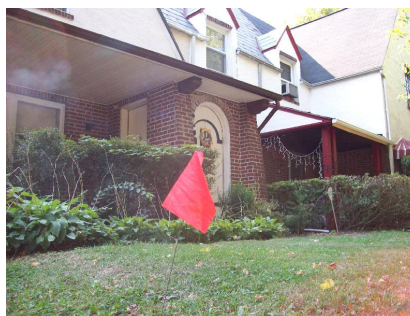
Picture \S1028-033-OB04-P01.jpg

Comments Smoke from cleanout in front yard. 3517 Wabash Ave.

Comments Front of house, 3517 Wabash Ave.

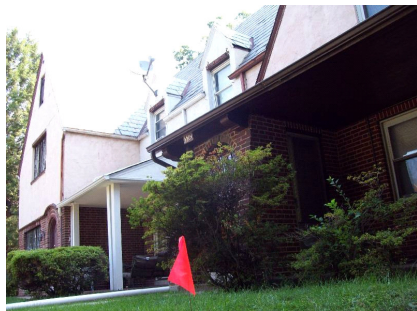
Picture \S1028-033-OB05-P01.jpg

Comments Smoke from cleanout in front yard. 3519 Wabash Ave.

Comments Front of house, 3519 Wabash Ave.

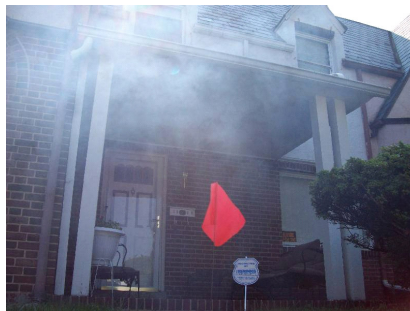
Picture \S1028-033-OB06-P01.jpg

Comments Smoke from cleanout in front yard. 3521 Wabash Ave.

Comments Front of house, 3521 Wabash Ave.

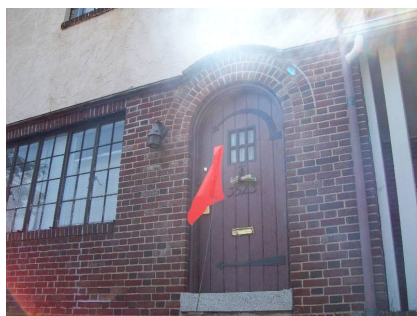
Picture \S1028-033-OB07-P01.jpg

Comments Smoke from cleanout in front yard. 3523 Wabash Ave.

Comments Front of house, 3523 Wabash Ave.

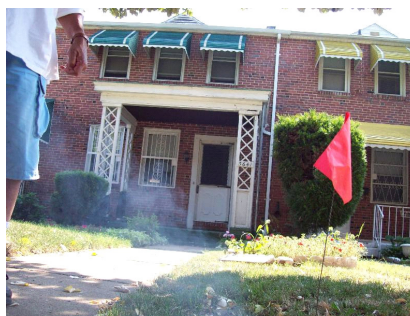
Picture \S1028-033-OB08-P01.jpg

Comments Smoke from cleanout in front yard. 3641 Wabash Ave.

Comments Front of house, 3641 Wabash Ave.

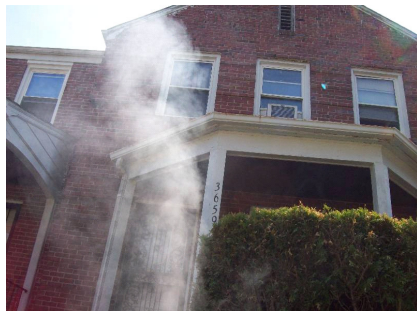
Picture \S1028-033-OB09-P01.jpg

Comments Smoke from cleanout in front yard. 3659 Wabash Ave.

Comments Front of house, 3659 Wabash Ave.
